# DUNE WALKWAY INVENTORY

Seabrook, NH

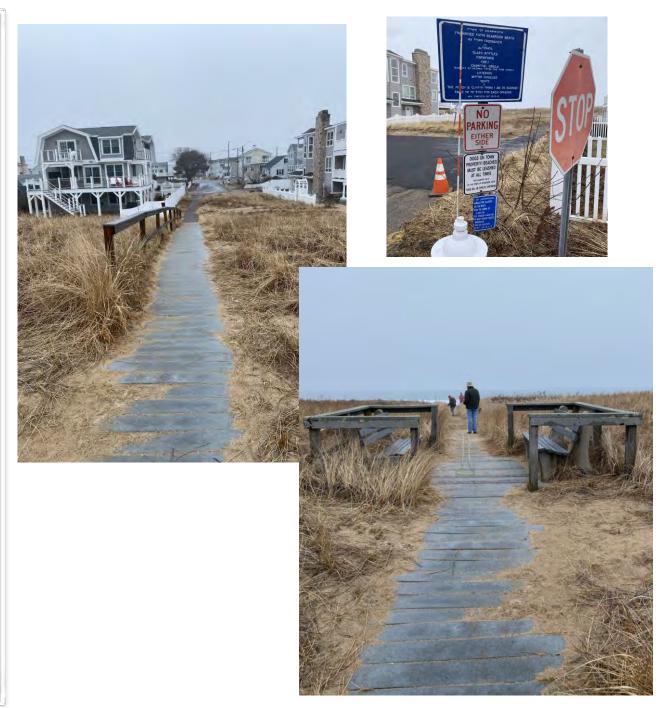
# Amesbury Street

Walkway Phys	sical Condition Good Condition
Road to Beach	433 ft
Walkway Length	363 ft
Sand path to Beach	70 ft
Walkway Width	4.0 ft
Walkway Material	<ul><li>Asphalt apron</li><li>Composite &amp; Wooden planks</li></ul>
Surface Condition	Solid/Minimal tilting
Dune Slope	Medium
Attached pathways	
Benches	4
Additional Features	Railings & viewing platform

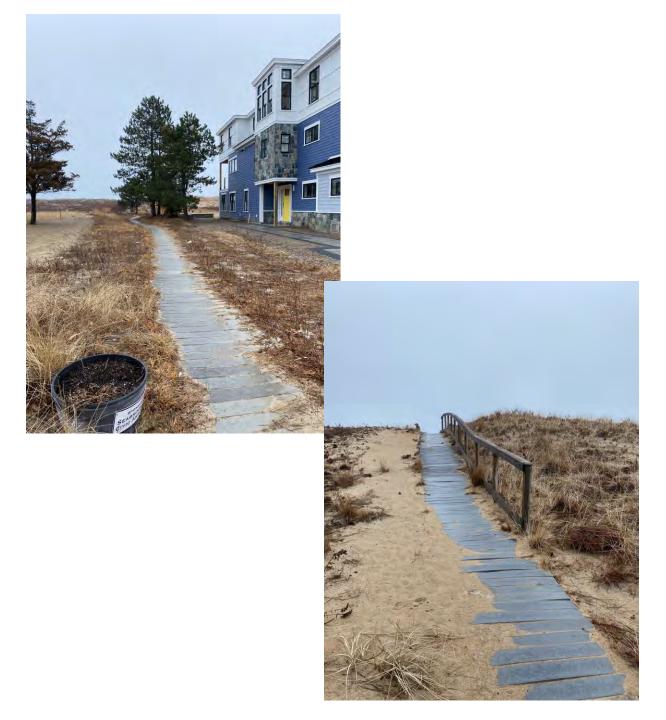
## Andover Street

Walkway Physical Condition		Fair Condition
Road to Beach		
Walkway Length	467 ft	
Sand path to Beach	70 ft	
Walkway Width	4.0 ft	
Walkway Material	<ul> <li>Asphalt apron</li> <li>Composite &amp; Woo planks</li> </ul>	oden
Surface Condition	Some tilting, loose bo overgrown brush imp walkway	
Dune Slope	Medium	
Attached pathways	3	
Benches	4	
Additional Features	Railings and benches	3

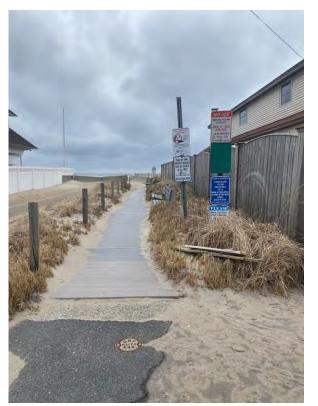
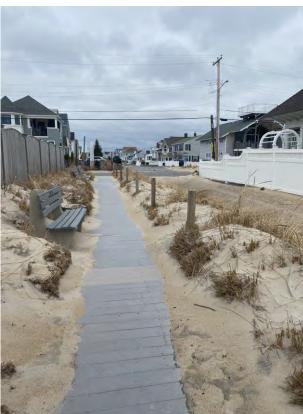
## Ashland Street

Walkway Physical Condition		Good Condition
Road to Beach

NUAU LU DEACH	
Walkway Length	82 ft
Sand path to Beach	70 ft
Walkway Width	5.3 ft
Walkway Material	<ul><li>Asphalt apron</li><li>Composite &amp; Wooden planks</li></ul>
Surface Condition	Solid/Minimal tilting
Dune Slope	Medium
Attached pathways	
Benches	4
Additional Features	Wooden posts separating walkway from driveway

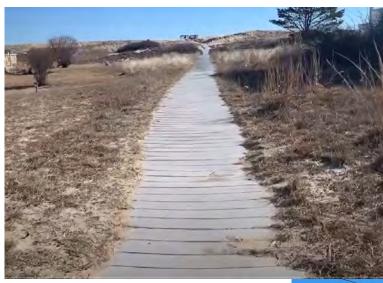
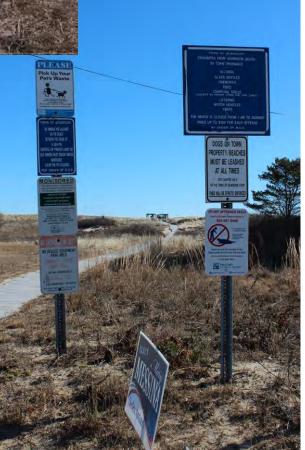
## **Chelmsford Street**

Walkway Physical Condition Good		
Road to Beach	433 ft	
Walkway Length	495 ft	
Sand path to Beach	87 ft	
Walkway Width	4.0 ft	
Walkway Material	<ul> <li>Asphalt apron</li> <li>Composite &amp; Wooden planks</li> </ul>	
Surface Condition	Solid/Minimal tilting	
Dune Slope	Medium	
Attached pathways		
Benches		
Additional Features	Railings & viewing platform

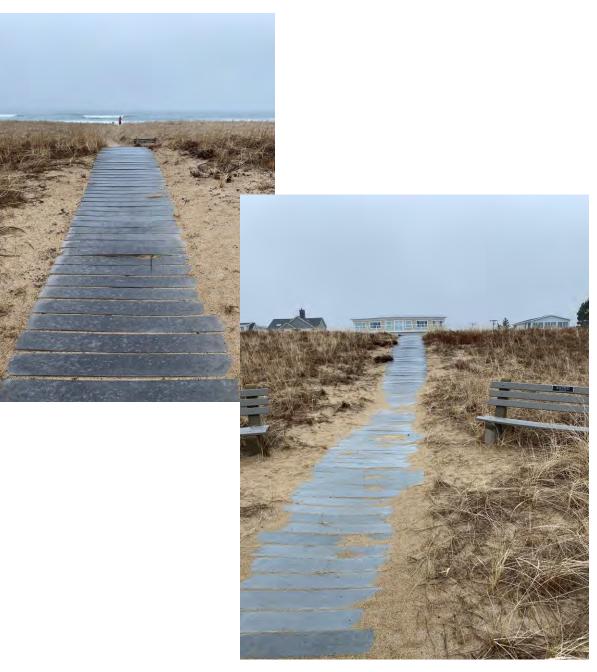
#### **Dracut Street**

Walkway Physical Condition		Good Condition
Road to Beach	433 ft	
Walkway Length	410 ft	
Sand path to Beach	88 ft	
Walkway Width	4.0 ft	
Walkway Material	<ul><li>Asphalt apron</li><li>Composite &amp; Wooden planks</li></ul>	
Surface Condition	Solid/Minimal tiltir	ıg
Dune Slope	Flat	
Attached pathways	2	
Benches		
Additional Features

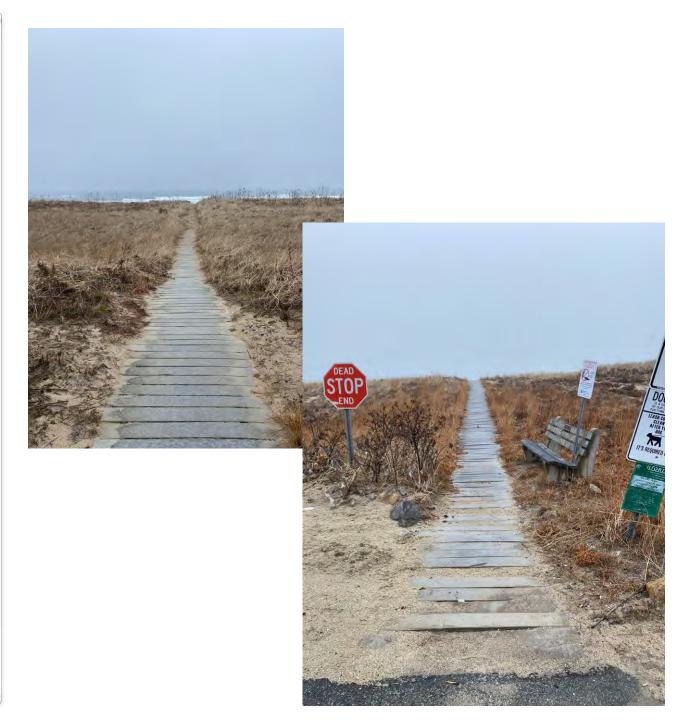
## **Groveland Street**

Walkway Phys	sical Condition Fair	
Road to Beach		
Walkway Length	185 ft	
Sand path to Beach	81ft	
Walkway Width	4.0 ft	
Walkway Material	<ul><li>Asphalt apron</li><li>Composite &amp; Wooden planks</li></ul>	
Surface Condition	Some loose boards, minor tilting	
Dune Slope	Medium	
Attached pathways		
Benches		
Additional Features

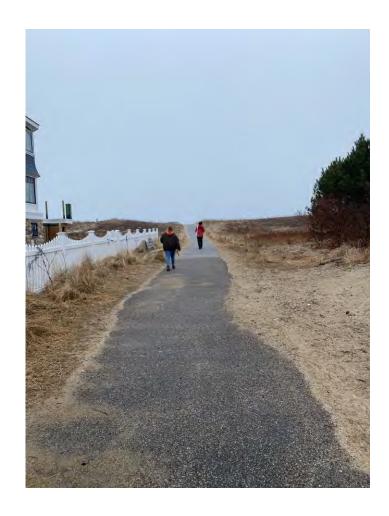
## Haverhill Street

Walkway Physical Condition Go	
Road to Beach	433 ft
Walkway Length	308 ft
Sand path to Beach	77 ft
Walkway Width	8.0 ft
Walkway Material	<ul><li>Asphalt apron</li><li>Composite &amp; Wooden planks</li></ul>
Surface Condition	Solid/Minimal tilting
Dune Slope	Medium
Attached pathways	
Benches	
Additional Features

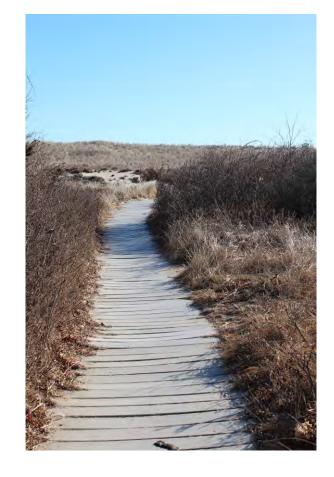
## Hudson Street

Walkway Physical Condition		Good Condition
Road to Beach		
Walkway Length	420 ft	
Sand path to Beach	60 ft	
Walkway Width	4.0 ft	
Walkway Material	<ul><li>Asphalt apron</li><li>Composite &amp; Wooden planks</li></ul>	
Surface Condition	Solid/Minimal tilting toward crest of the dune	
Dune Slope	Medium	
Attached pathways		
Benches		
Additional Features	birdhouses

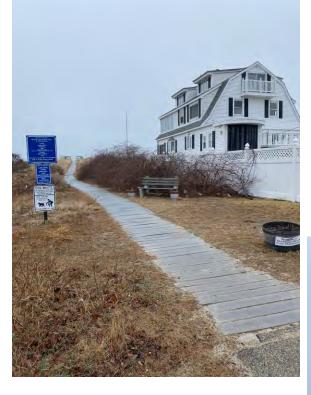
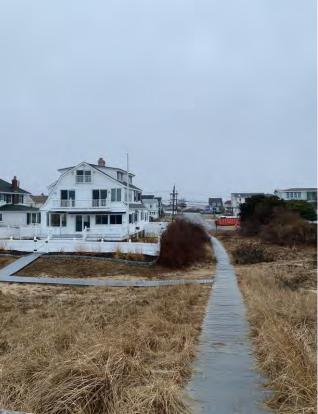
#### Lawrence Street

Walkway Physical Condition Good	
Road to Beach	
Walkway Length	415 ft
Sand path to Beach	89 ft
Walkway Width	4.0 ft
Walkway Material	<ul><li>Asphalt apron</li><li>Composite &amp; Wooden planks</li></ul>
Surface Condition	Solid/Minimal tilting
Dune Slope	Medium
Attached pathways	2
Benches	
Additional Features	Nonslip material

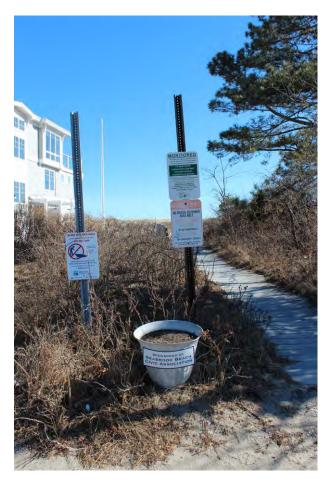
Lowell Street		
Walkway Physical Condition Good		
Road to Beach		
Walkway Length	430 ft	
Sand path to Beach	70 ft	
Walkway Width	4.0 ft	
Walkway Material	<ul> <li>Asphalt apron</li> <li>Composite &amp; Wooden planks</li> </ul>	
Surface Condition	Solid/Minimal tiltin	g
Dune Slope	Flat	
Attached pathways	2	
Benches		
Additional Features	Viewing point with	benches

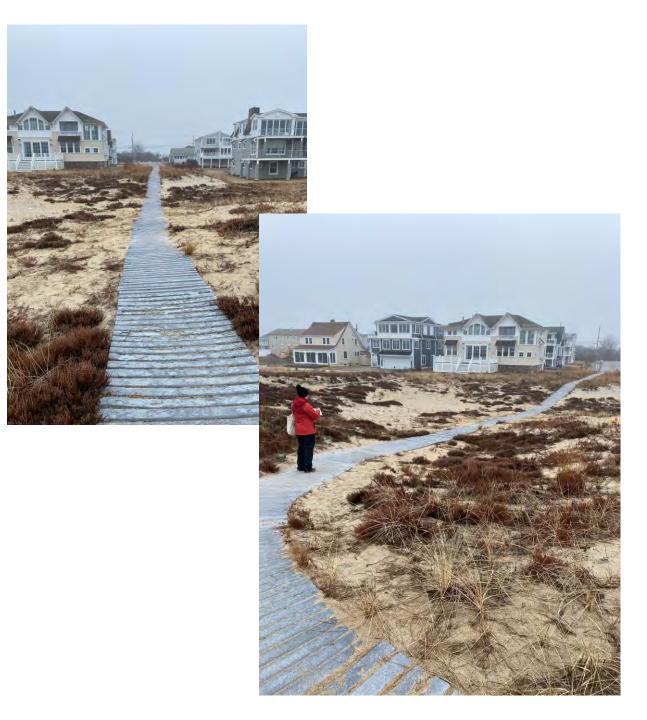
# Merrimack Street

Walkway Phys	sical Condition Fair
Road to Beach	
Walkway Length	380 ft
Sand path to Beach	94 ft
Walkway Width	4.0 ft
Walkway Material	<ul><li>Asphalt apron</li><li>Composite &amp; Wooden planks</li></ul>
Surface Condition	Loose boards
Dune Slope	Flat / windy
Attached pathways	3 with others seen adjacent
Benches	1
Additional Features

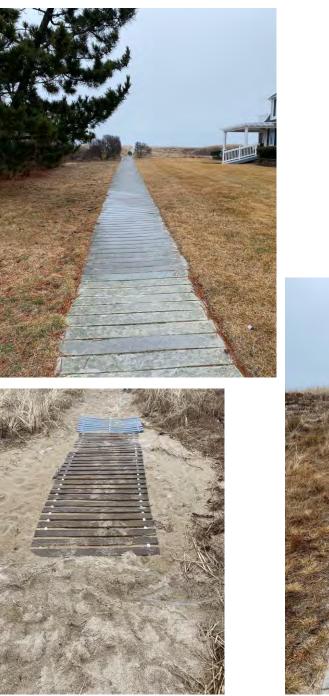
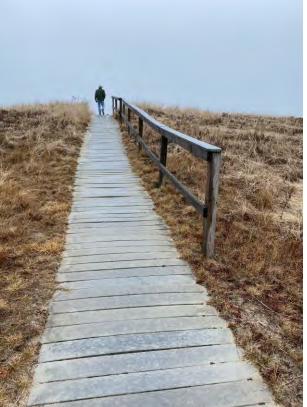
## Methuen Street

Walkway Phys	sical Condition	Good Condition
Road to Beach		
Walkway Length	453 ft	
Sand path to Beach	89 ft	
Walkway Width	4.0 ft	
Walkway Material	<ul> <li>Asphalt apron</li> <li>Composite &amp; V planks</li> </ul>	/ooden
Surface Condition	Solid	
Dune Slope	Flat	
Attached pathways	2	
Benches	2	
Additional Features	Railings, detached of wooden planks walkway

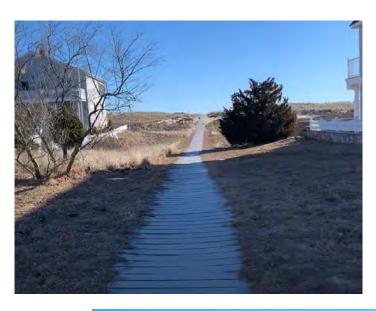
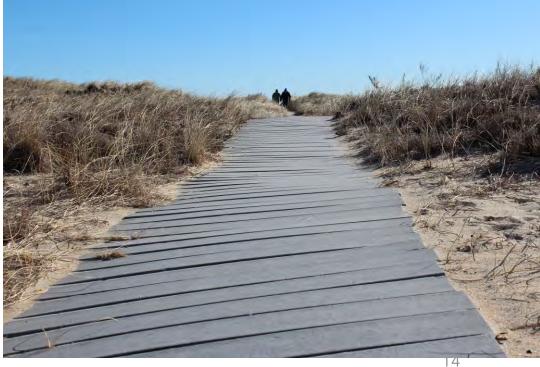
# Nashua Street

Walkway Physic	al Condition Good
Road to Beach	
Walkway Length	520 ft
Sand path to Beach	71 ft
Walkway Width	3.1 ft
Walkway Material	<ul><li>Asphalt apron</li><li>Composite &amp; Wooden planks</li></ul>
Surface Condition	Minor tilting, some loose boards
Dune Slope	Medium
Attached pathways	1
Benches	
Additional Features

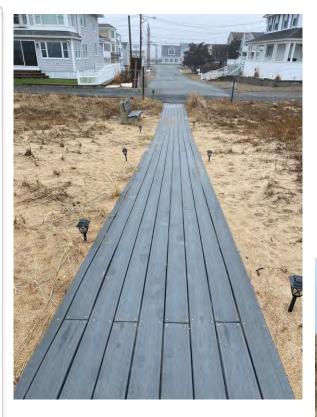
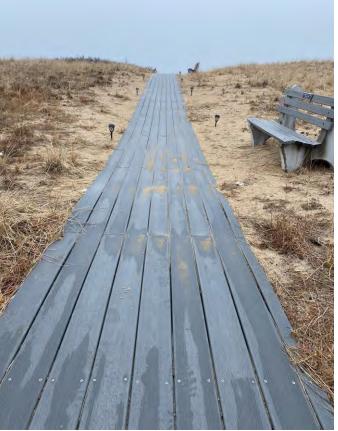
# Newbury Street

Walkway Phys	sical Condition	Good Condition
Road to Beach		
Walkway Length	102 ft	
Sand path to Beach	136 ft	
Walkway Width	4.0 ft	
Walkway Material	<ul> <li>Asphalt apron</li> <li>Composite &amp; V planks</li> </ul>	Vooden
Surface Condition	Newer	
Dune Slope	Medium	
Attached pathways		
Benches		
Additional Features	Lights along walkw	vay

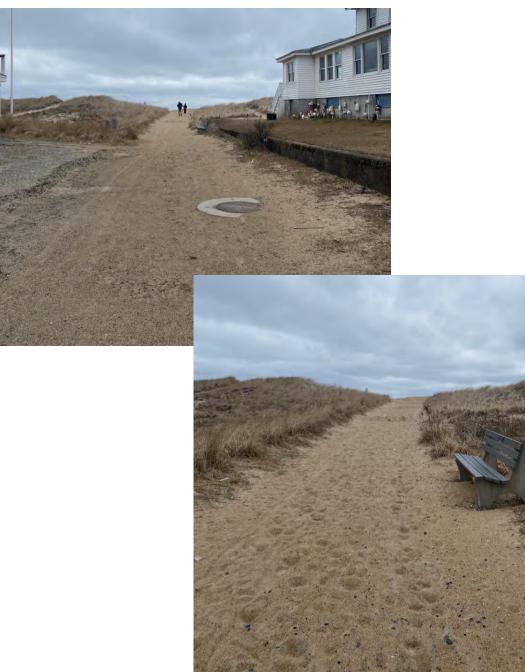
New Hampshire Street		
Walkway Phys	sical Condition	Good Condition
Road to Beach		
Walkway Length	239 ft	
Sand path to Beach	NA – all sand	
Walkway Width		
Walkway Material	Sand path	
Surface Condition	Flat	
Dune Slope	None	
Attached pathways	3	
Benches	2	
Additional Features

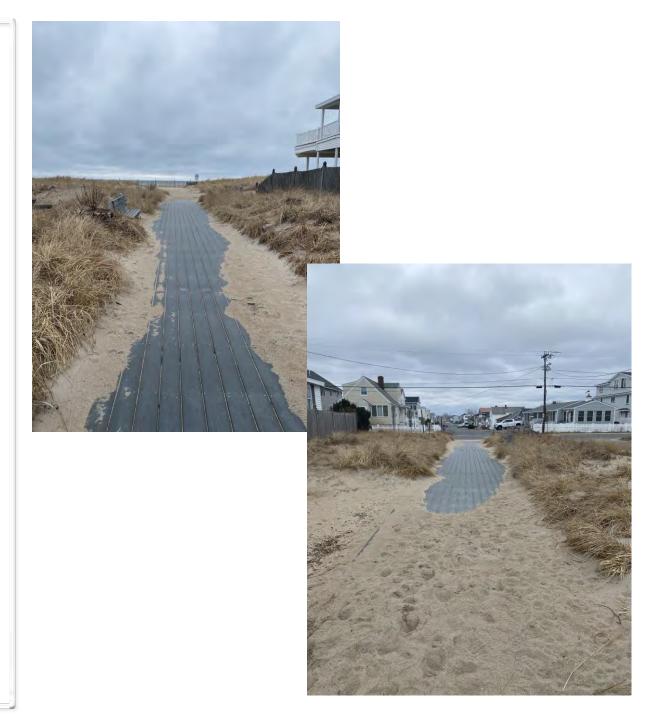
## **Tilton Street**

Walkway Phys	sical Condition Good Condition
Road to Beach	
Walkway Length	83 ft
Sand path to Beach	80 ft
Walkway Width	8.0 ft
Walkway Material	<ul><li>Asphalt apron</li><li>Composite &amp; Wooden planks</li></ul>
Surface Condition	Solid
Dune Slope	NA not on a dune
Attached pathways	None
Benches	1
Additional Features

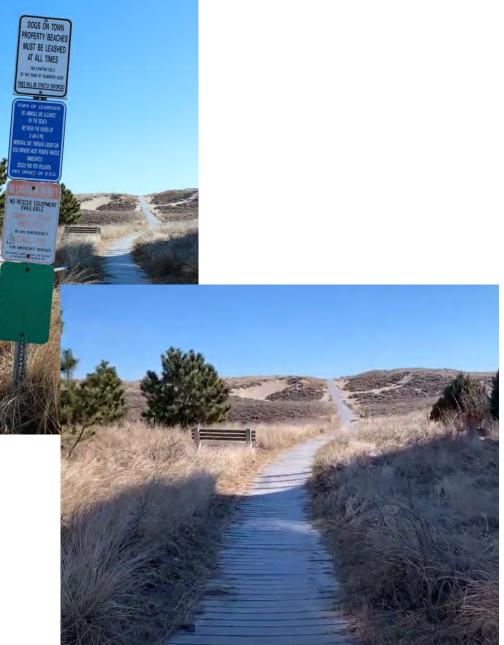
Walkway Physical Condition       Good         Condition       Condition         Road to Beach       Condition
Road to Beach
Walkway Length 500 ft
Sand path to Beach 80 ft
Walkway Width 4 ft
<ul> <li>Asphalt apron</li> <li>Walkway Material</li> <li>Composite &amp; Wooden planks</li> </ul>
Surface Condition Solid/Minimal tilting
Dune Slope Medium
Attached pathways 2
Benches 3
