Seabrook Dune Walkway Evaluation Final Report

Photo Credit: Tom Morgan

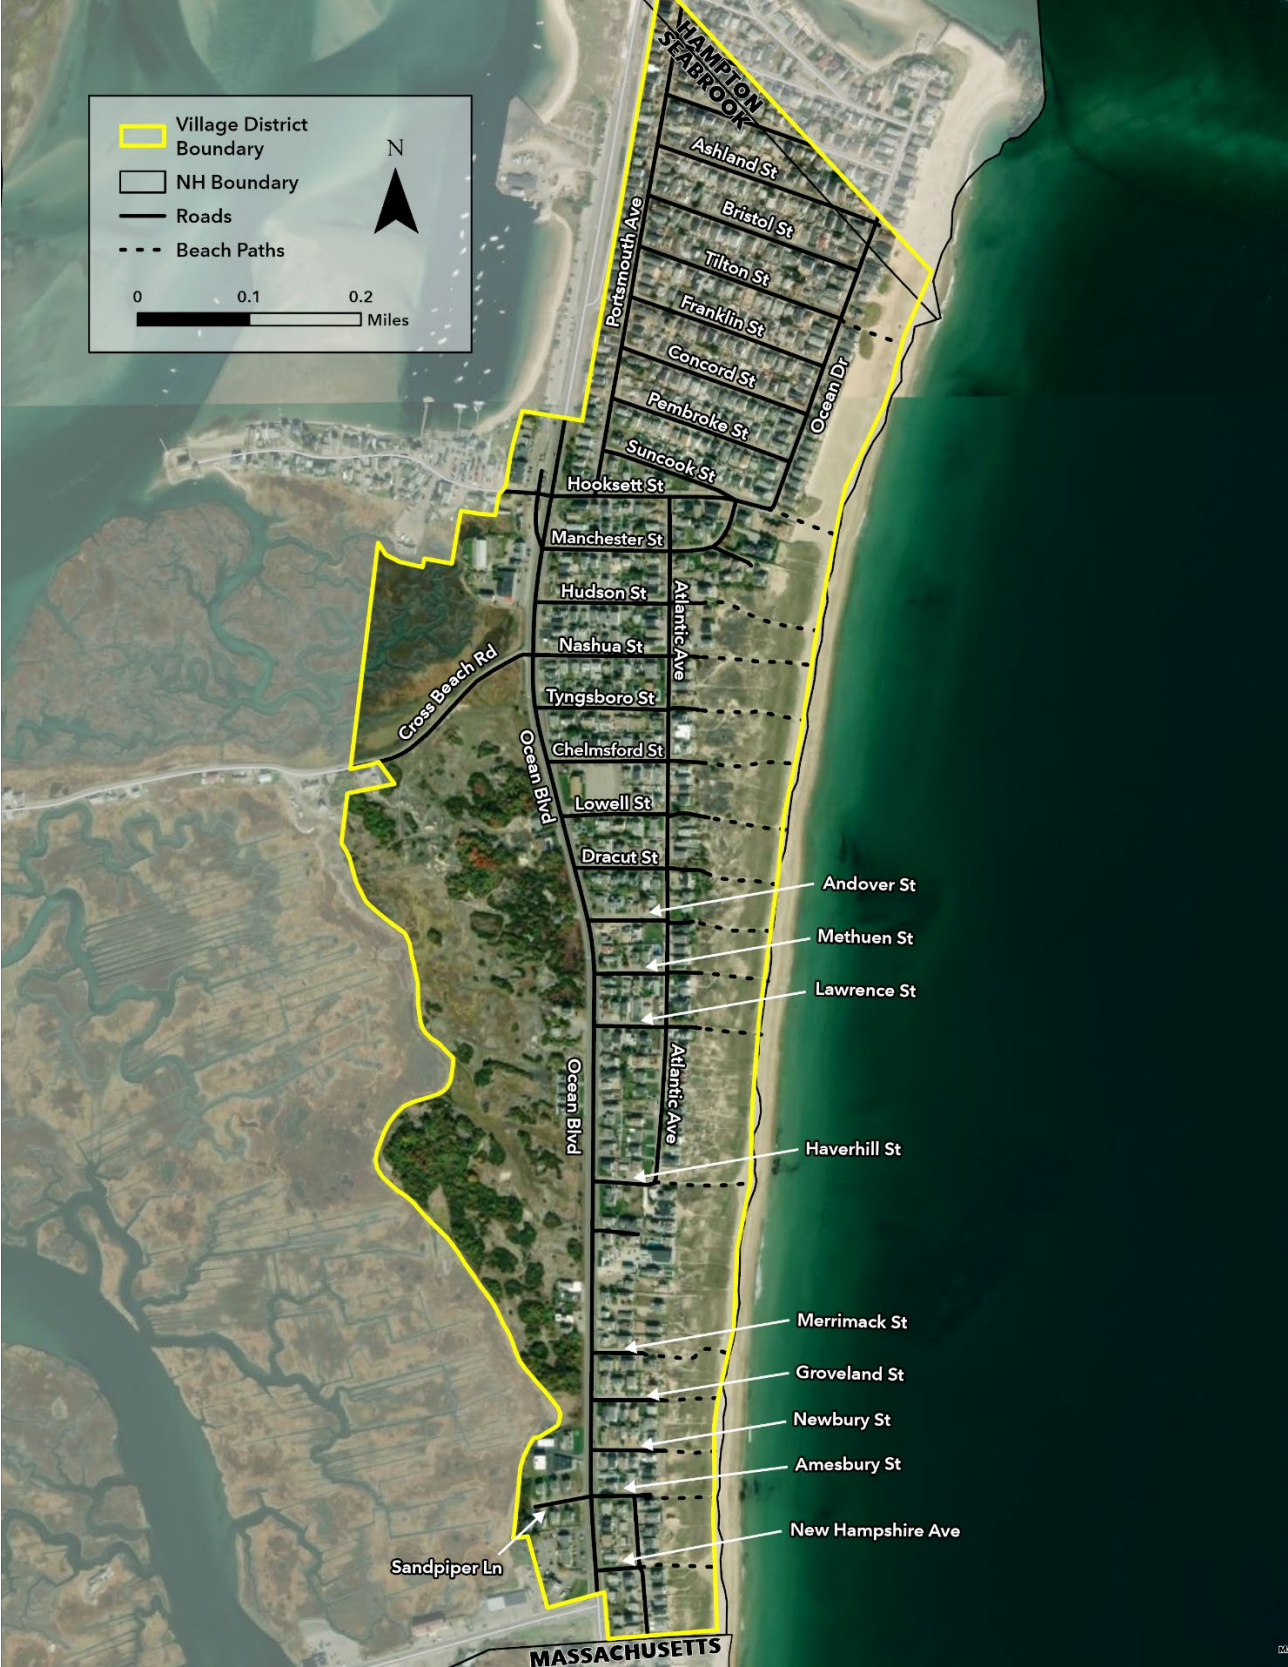
Figure 1: Seabrook Beach and Public Access Streets

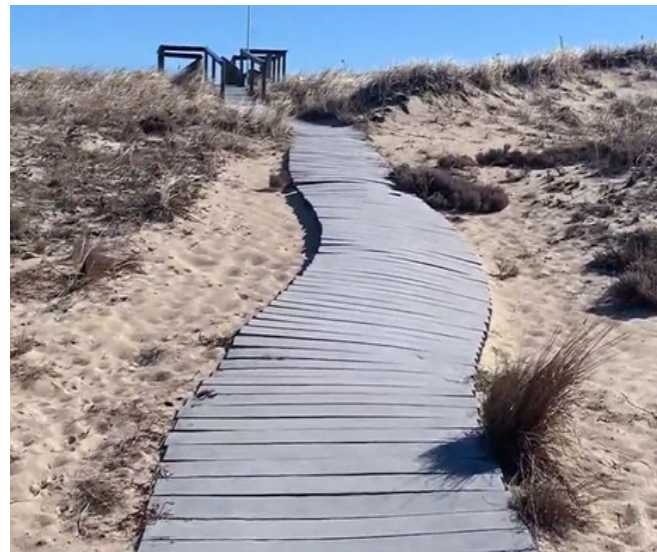
Figure 2: Shifting boardwalk foundation; bare areas of sand and footsteps observed alongside the walkway; Chelmsford Street

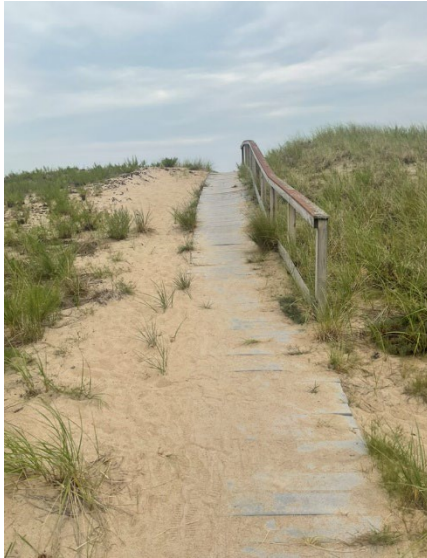
Figure 3: Sand accumulation on boardwalk, bare areas of sand and footsteps observed alongside the walkway; Andover Street

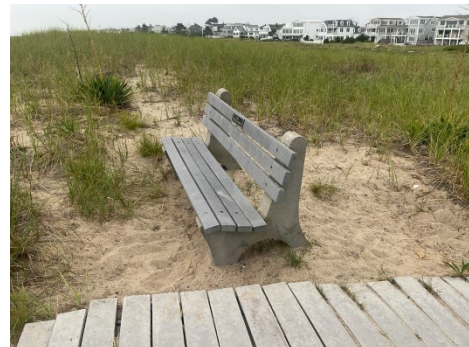
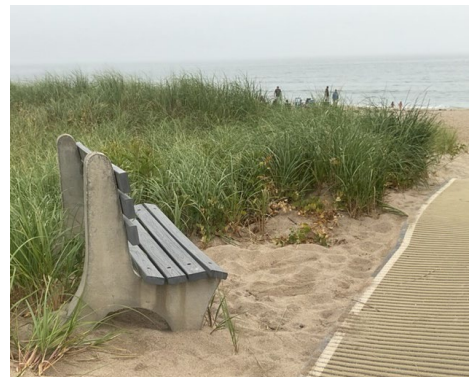
Figure 4: Observed difference in pedestrian impact with bench orientation.

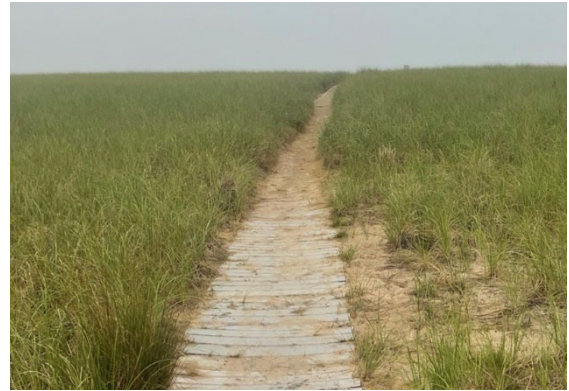
Figure 7: Beachgrass grassland

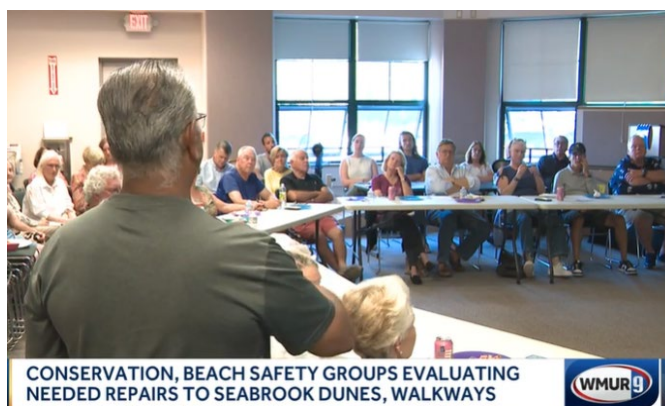
Figure 8: Select Board Member Ravi Ravikumar addresses residents at Public Workshop May 28, 2024, retrieved from WMUR

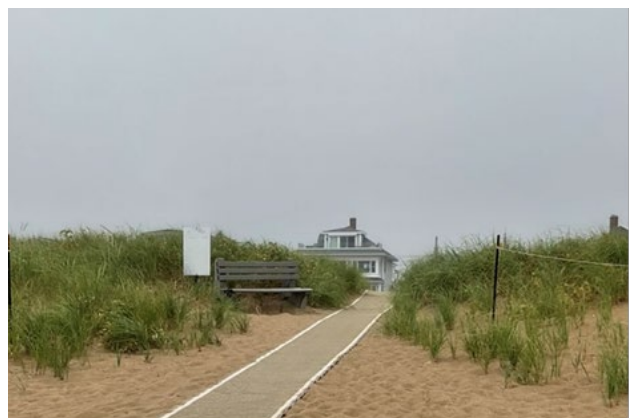
Figure 9: Mobi Mat at Groveland Street, Seabrook

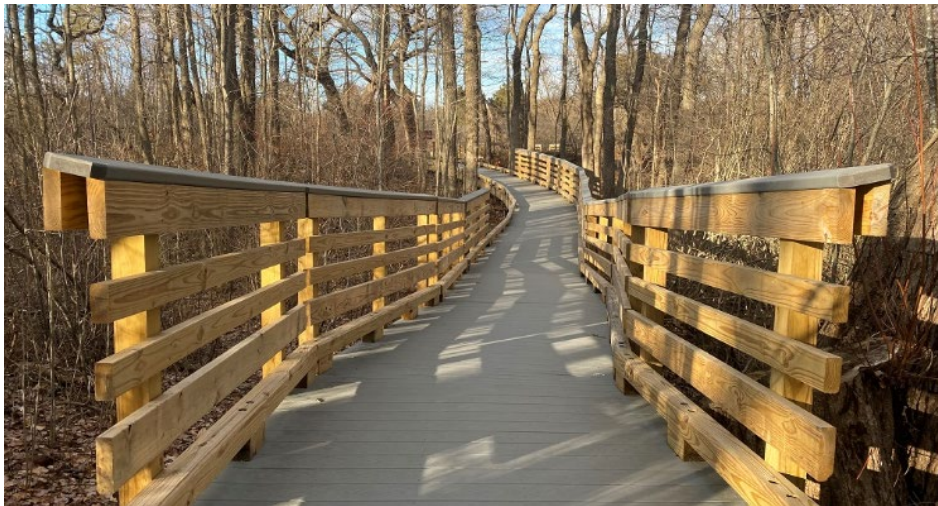
The Hellcat Interpretive Trail in the Parker River National Wildlife Refuge on Plum Island is a 1.4-mile boardwalk system that traverses both dune and marsh habitats and was designed with public access and environmental education in mind. Divided into two segments, the boardwalk includes interpretive signage, wildlife observation areas, and a fully accessible surface suitable for wheelchairs and strollers.

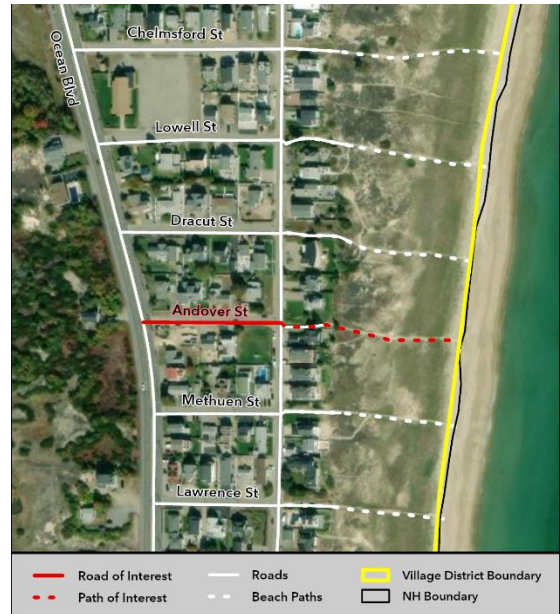
Ecological Conditions and Observations			
Community Types Present	Rare Species	Other Native Species of interest	Species of Concern
<ul style="list-style-type: none"> Beachgrass grassland Hudsonia maritime shrubland 	<ul style="list-style-type: none"> Wooly beach heather (<i>Hudsonia tomentosa</i>)^{S2} Gray's sedge (<i>Cyperus grayi</i>)^{S1} Tall wormwood (<i>Artemisia campestris</i>)^{S1} 	<ul style="list-style-type: none"> Beachgrass (<i>Ammophila breviligulata</i>) Seaside goldenrod (<i>Solidago sempervirens</i>) Beach pea (<i>Lathyrus japonicus</i>) Beach plum (<i>Prunus maritima</i>) 	<ul style="list-style-type: none"> Asiatic bittersweet (<i>Celastrus orbiculatus</i>)^P Shrub honeysuckle (<i>Lonicera</i> species)^P Autumn olive (<i>Elaeagnus umbellata</i>)^P Climbing nightshade (<i>Solanum dulcamara</i>)^W

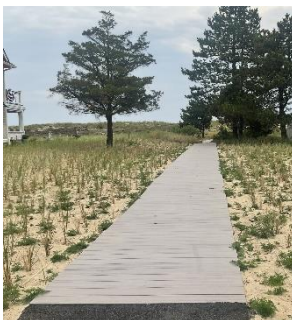
S1 = endangered in NH, S2 = threatened in NH, P = prohibited species in NH, W = NH invasive watch list

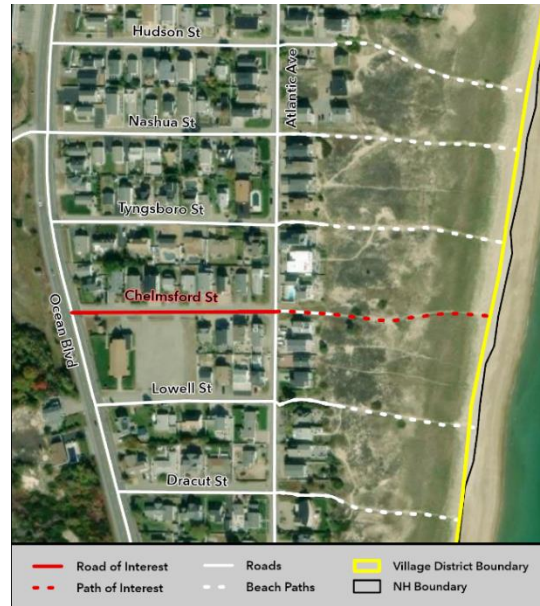
Ecological Conditions and Observations			
Community Types Present	Rare Species	Other Native Species of interest	Species of Concern
<ul style="list-style-type: none"> • Beachgrass grassland • Hudsonia maritime shrubland 	<ul style="list-style-type: none"> • Woolly beach heather (<i>Hudsonia tomentosa</i>)^{S2} • Tall wormwood (<i>Artemisia campestris</i>)^{S1} 	<ul style="list-style-type: none"> • Beachgrass (<i>Ammophila breviligulata</i>) • Seaside goldenrod (<i>Solidago sempervirens</i>) • Northern Bayberry (<i>Myrica pennsylvanica</i>) • Beach plum (<i>Prunus maritima</i>) 	<ul style="list-style-type: none"> • Asiatic bittersweet (<i>Celastrus orbiculatus</i>)^P • Shrub honeysuckle (<i>Lonicera species</i>)^P • Beach rose (<i>Rosa rugosa</i>)^W
S1 = endangered in NH, S2 = threatened in NH, P = prohibited species in NH, W = NH invasive watch list

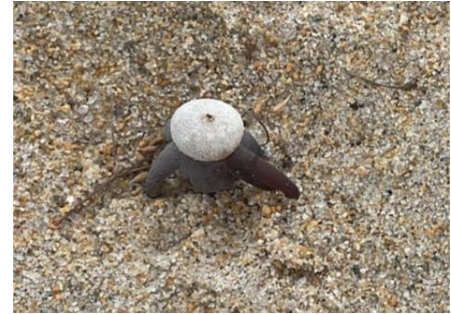
Figure 4: Earthstar mushrooms found at this site

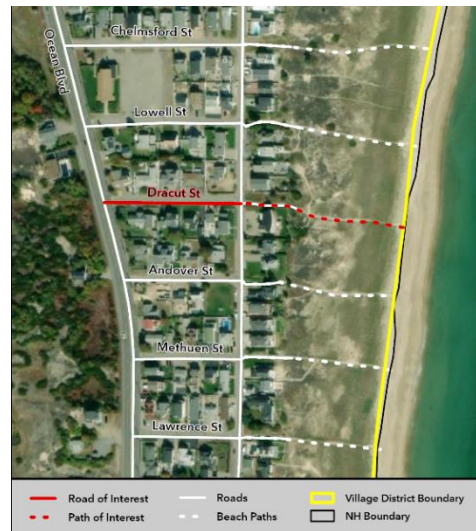
Structure Conditions and Observations:	
Road to Beach	498 ft
Walkway Length	410 ft
End of walkway to beach	88 ft
Walkway Width	4.0 ft
Walkway Material	<ul style="list-style-type: none"> Asphalt apron Pressure treated wood connected by cable
Attached pathways	2
Benches	4
Additional Features	None
<i>*Human-made pathways connected to the municipal walkway</i>

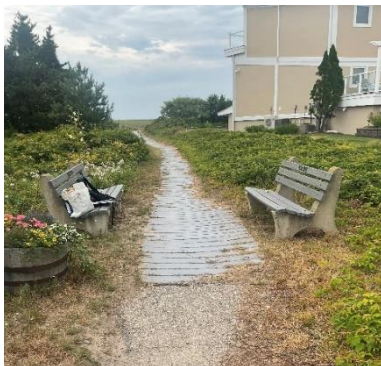
S2 = threatened in NH, P = prohibited species in NH, W = NH invasive watch list

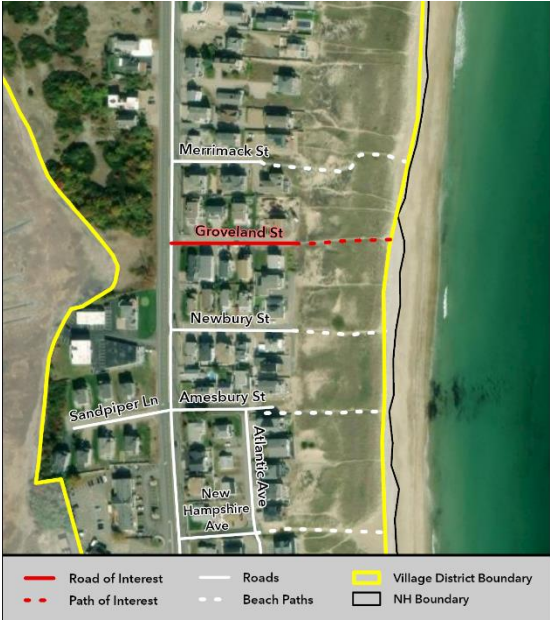
Ecological Conditions and Observations			
Community Types Present	Rare Species	Other Native Species of interest	Species of Concern
<ul style="list-style-type: none"> Beachgrass grassland Hudsonia maritime shrubland 	<ul style="list-style-type: none"> Woolly beach heather (<i>Hudsonia tomentosa</i>)^{S2} Tall wormwood (<i>Artemisia campestris</i>)^{S1} 	<ul style="list-style-type: none"> Beachgrass (<i>Ammophila breviligulata</i>) Seaside goldenrod (<i>Solidago sempervirens</i>) Beach pea (<i>Lathyrus japonicus</i>) Seabeach pinweed (<i>Lechea maritima</i>) Poison ivy (<i>Toxicodendron radicans</i>) 	<ul style="list-style-type: none"> Asiatic bittersweet (<i>Celastrus orbiculatus</i>)^P Beach rose (<i>Rosa rugosa</i>)^W
S1 = endangered in NH, S2 = threatened in NH, P = prohibited species in NH, W = NH invasive watch list)

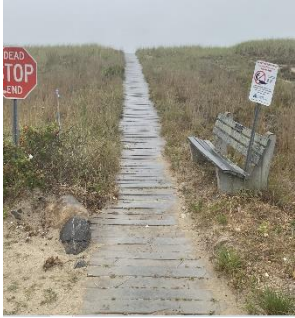
Walkway Entrance &
Landward side

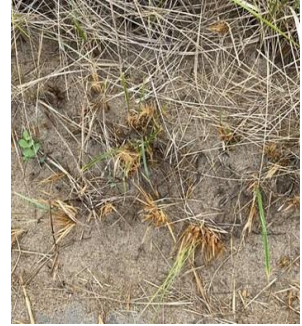
Figure 1. Cut vegetation along walkway edge

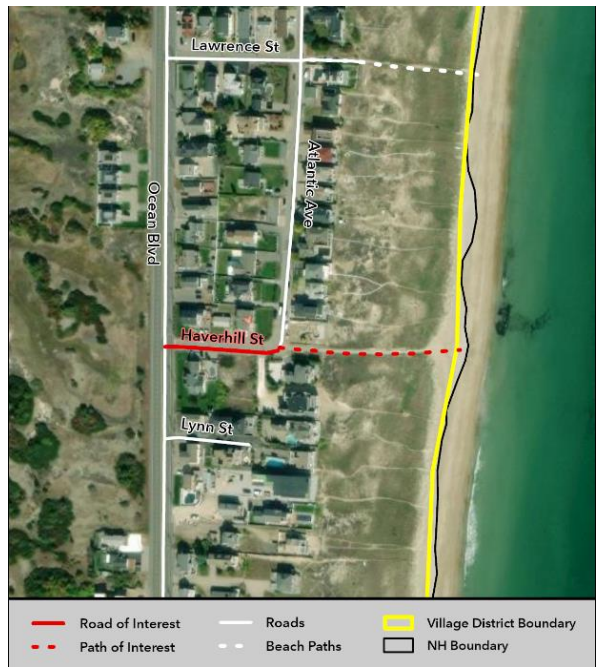
Ecological Conditions and Observations			
Community Types Present	Rare Species	Other Native Species of interest	Species of Concern
<ul style="list-style-type: none"> Beachgrass grassland 	<ul style="list-style-type: none"> Seaside goldenrod (<i>Solidago sempervirens</i>) 	<ul style="list-style-type: none"> Beachgrass (<i>Ammophila breviligulata</i>) Goldenrod (<i>Solidago sempervirens</i>) Beach pea (<i>Lathyrus japonicus</i>) 	<ul style="list-style-type: none"> Japanese knotweed (<i>Renoutria japonica</i>)^P Beach rose (<i>Rosa rugosa</i>)^W
P = prohibited species in NH, W = NH invasive watch list

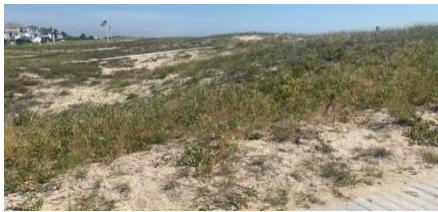
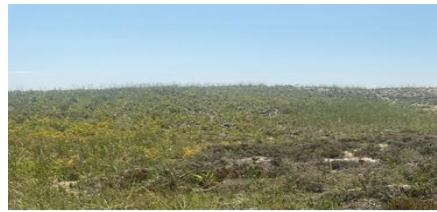
Figure 3. Vegetation to north of the walkway (right) is more sparse than south (left)

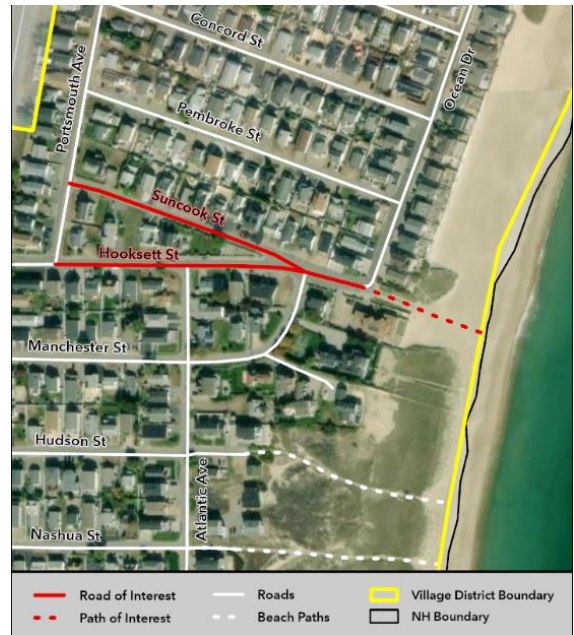
Ecological Conditions and Observations			
Community Types Present	Rare Species	Other Native Species of Interest	Species of Concern
NA	None observed on assessment dates	<ul style="list-style-type: none"> Beachgrass (<i>Ammophila breviligulata</i>) Seaside goldenrod (<i>Solidago sempervirens</i>) Beach pea (<i>Lathyrus japonicus</i>) Northern Bayberry (<i>Myrica pennsylvanica</i>) 	None observed on assessment dates

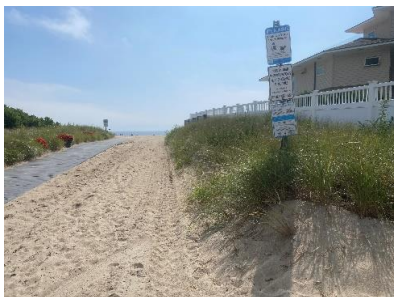
Right side of walkway – large adjacent pathway

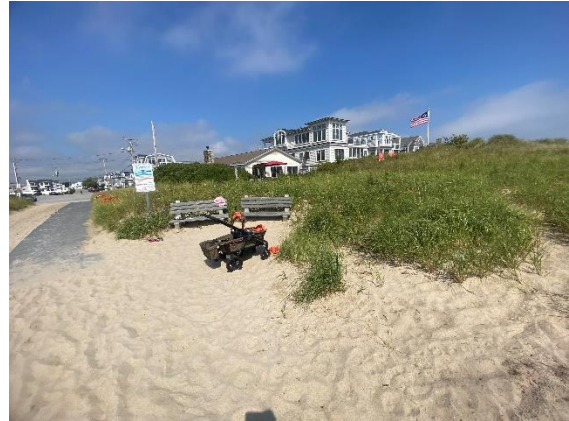
Figure 1: Dunes present adjacent to the walkway

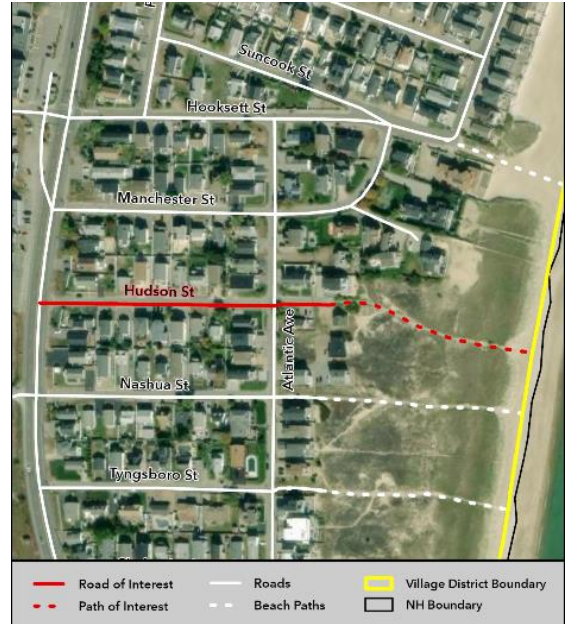
Ecological Conditions and Observations			
Community Types Present	Rare Species	Other Native Species of Interest	Species of Concern*
<ul style="list-style-type: none"> • Beachgrass grassland • Hudsonia maritime shrubland 	<ul style="list-style-type: none"> • Woolly beach heather (<i>Hudsonia tomentosa</i>)^{S2} 	<ul style="list-style-type: none"> • Beachgrass (<i>Ammophila breviligulata</i>) • Seaside goldenrod (<i>Solidago sempervirens</i>) • Beach pea (<i>Lathyrus japonicus</i>) • Northern Bayberry (<i>Myrica pennsylvanica</i>) • Common milkweed (<i>Asclepias syriaca</i>) 	<ul style="list-style-type: none"> • Asiatic bittersweet^P (<i>Celastrus orbiculatus</i>) • Beach rose^W (<i>Rosa rugosa</i>) • Yucca species (likely <i>Yucca filamentosa</i>) • Shrub honeysuckle^P (<i>Lonicera species</i>)

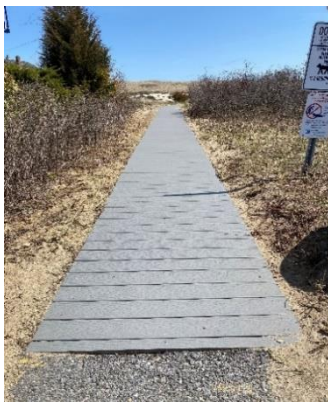
Walkway entrance (2025)

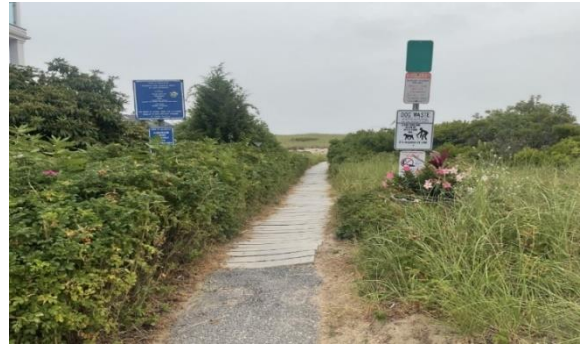
Figure 1: Invasive species at the entrance to the walkway

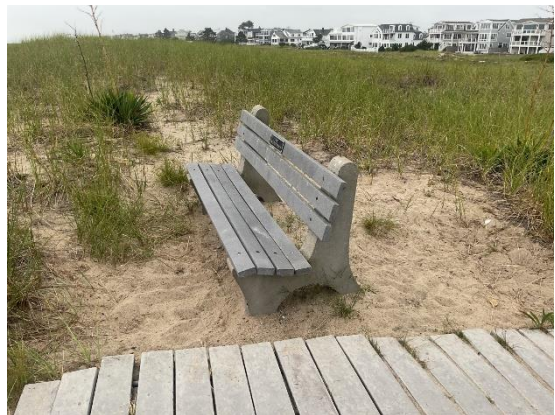
Figure 3: Bench placed perpendicular to the boardwalk exhibits surrounding unvegetated areas. Consider repositioning the bench and revegetating.

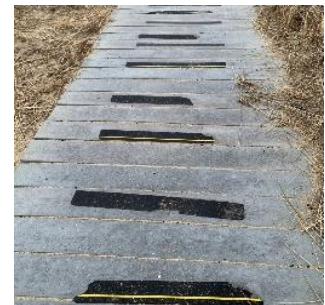
Figure 3. Previously installed slip resistant tape

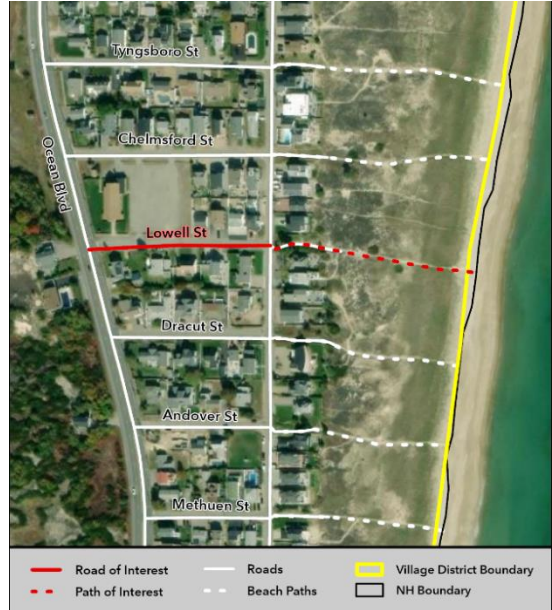
Structure Conditions and Observations:	
Road to Beach	500 ft
Boardwalk Length	430 ft
End of boardwalk to the beach	70 ft
Walkway Width	4.0 ft
Walkway Material	<ul style="list-style-type: none"> Asphalt apron Pressure treated wood connected by cable
Connected pathways**	2
Benches	3
Additional Features	viewing platform at crest of dune with benches
<i>*Human-made pathways connected to the municipal walkway</i>

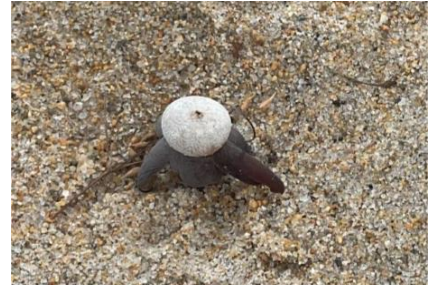
Figure 3: Earthstar mushroom found at this site

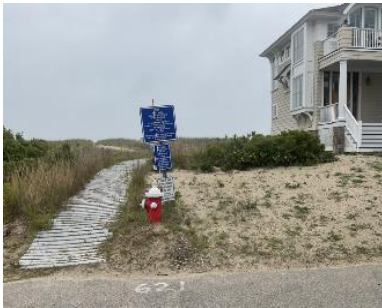
Figure 1. Unvegetated area near

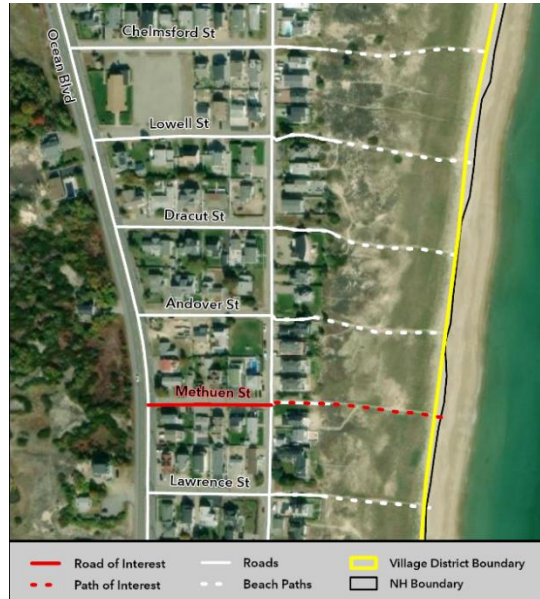
Ecological Conditions and Observations			
Community Types Present	Rare Species	Other Native Species of interest	Species of Concern
<ul style="list-style-type: none"> Beachgrass grassland Hudsonia maritime shrubland 	<ul style="list-style-type: none"> Woolly beach heather (<i>Hudsonia tomentosa</i>)^{S2} Gray's sedge (<i>Cyperus grayi</i>)^{S1} Tall wormwood (<i>Artemisia campestris</i>)^{S1} 	<ul style="list-style-type: none"> Beachgrass (<i>Ammophila breviligulata</i>) Seaside goldenrod (<i>Solidago sempervirens</i>) Beach pea (<i>Lathyrus japonicus</i>) Beach plum (<i>Prunus maritima</i>) Seabeach pinweed (<i>Lechea maritima</i>) Bayberry (<i>Myrica pennsylvanica</i>) 	<ul style="list-style-type: none"> Asiatic bittersweet (<i>Celastrus orbiculatus</i>)^P

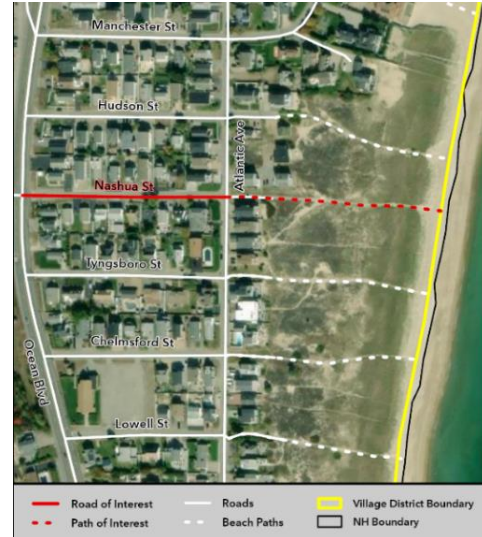
Ecological Conditions and Observations			
Community Types Present	Rare Species	Other Native Species of interest	Species of Concern
<ul style="list-style-type: none"> • Beachgrass grassland • Hudsonia maritime shrubland 	<ul style="list-style-type: none"> • Woolly beach heather (<i>Hudsonia tomentosa</i>)^{S2} 	<ul style="list-style-type: none"> • Beachgrass (<i>Ammophila breviligulata</i>) • Seaside goldenrod (<i>Solidago sempervirens</i>) • Northern Bayberry (<i>Myrica pennsylvanica</i>) 	<ul style="list-style-type: none"> • Autumn olive (<i>Elaeagnus umbellata</i>)^P • Climbing nightshade (<i>Solanum dulcamara</i>)^W • Beach rose (<i>Rosa rugosa</i>)^W
S2 = threatened in NH, P = prohibited species in NH, W = NH invasive watch list

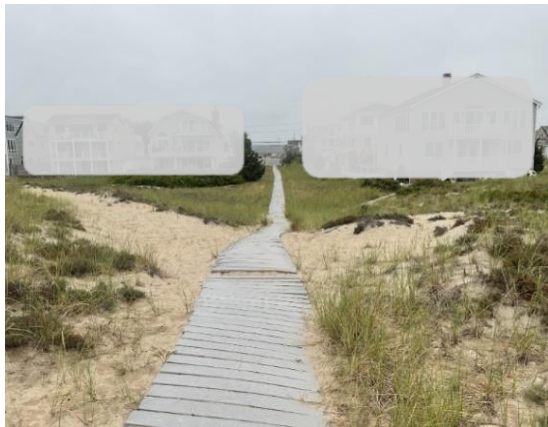
Figure 3: Large unvegetated areas adjacent to walkway

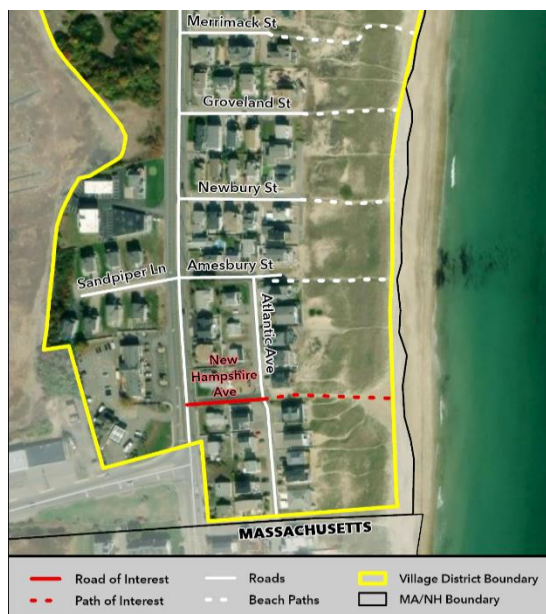
Ecological Conditions and Observations			
Community Types Present	Rare Species	Other Native Species of interest	Species of Concern
<ul style="list-style-type: none"> Beachgrass grassland 	None observed on assessment dates	<ul style="list-style-type: none"> Beachgrass (<i>Ammophila breviligulata</i>) Seaside goldenrod (<i>Solidago sempervirens</i>) Beach pea (<i>Lathyrus japonicus</i>) 	<ul style="list-style-type: none"> Asiatic bittersweet (<i>Celastrus orbiculatus</i>)^P Beach Rose (<i>Rosa rugosa</i>)^W Shrub honeysuckle (<i>Lonicera species</i>)^P
P = prohibited species in NH; W = NH invasive watch list

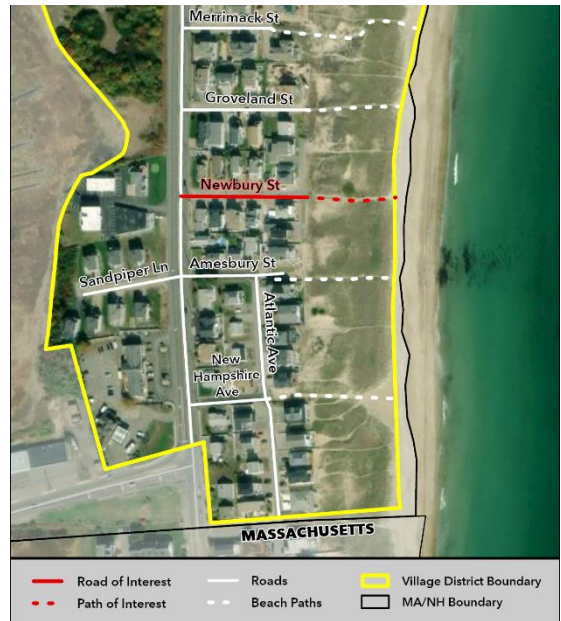
Ecological Conditions and Observations			
Community Types Present	Rare Species	Other Native Species of interest	Species of Concern
<ul style="list-style-type: none"> Beachgrass grassland 	<ul style="list-style-type: none"> Tall wormwood (<i>Artemisia campestris</i>)^{S1} 	<ul style="list-style-type: none"> Beachgrass (<i>Ammophila breviligulata</i>) Seaside goldenrod (<i>Solidago sempervirens</i>) Beach pea (<i>Lathyrus japonicus</i>) Seabeach pinweed (<i>Lechea maritima</i>) 	<ul style="list-style-type: none"> Asiatic bittersweet (<i>Celastrus orbiculatus</i>)^P Beach Rose (<i>Rosa rugosa</i>)^W
S1 = endangered in NH, P = prohibited species in NH, W = NH invasive watch list

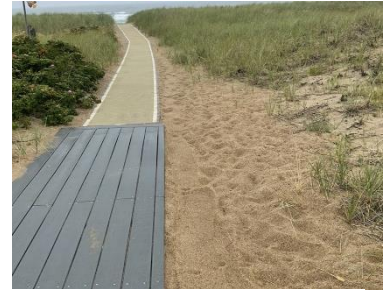
Figure 1. Foot traffic along walkway edges impacting vegetation

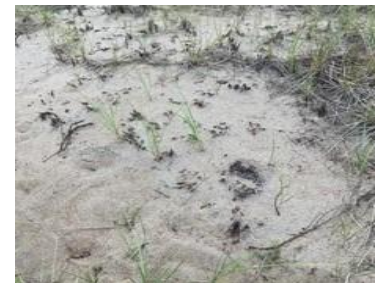
Figure 3. Unvegetated areas suggesting dune die-off

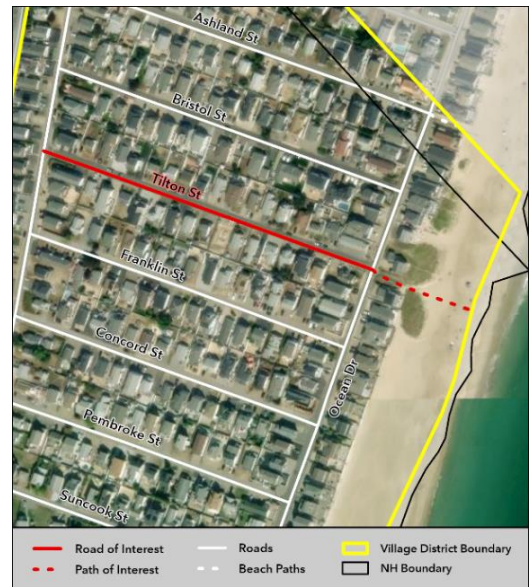
Ecological Conditions and Observations			
Community Types Present	Rare Species	Other Native Species of interest	Species of Concern
Not applicable	None observed on assessment dates	<ul style="list-style-type: none"> Beachgrass (<i>Ammophila breviligulata</i>) Seaside goldenrod (<i>Solidago sempervirens</i>) Beach pea (<i>Lathyrus japonicus</i>) Common Milkweed (<i>Asclepias syriaca</i>) 	None observed on assessment dates.

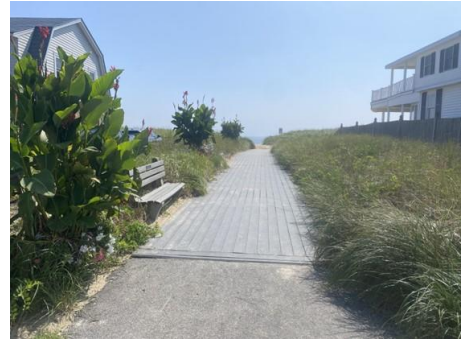
Figure 1: Landward side of walkway

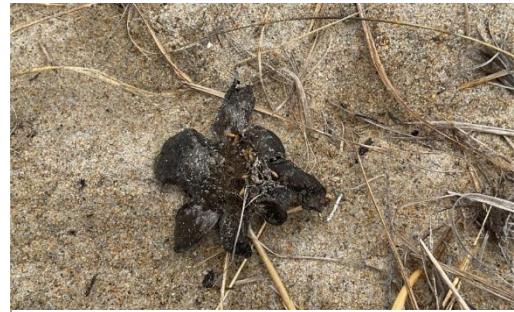
Figure 4: Earthstar Mushroom

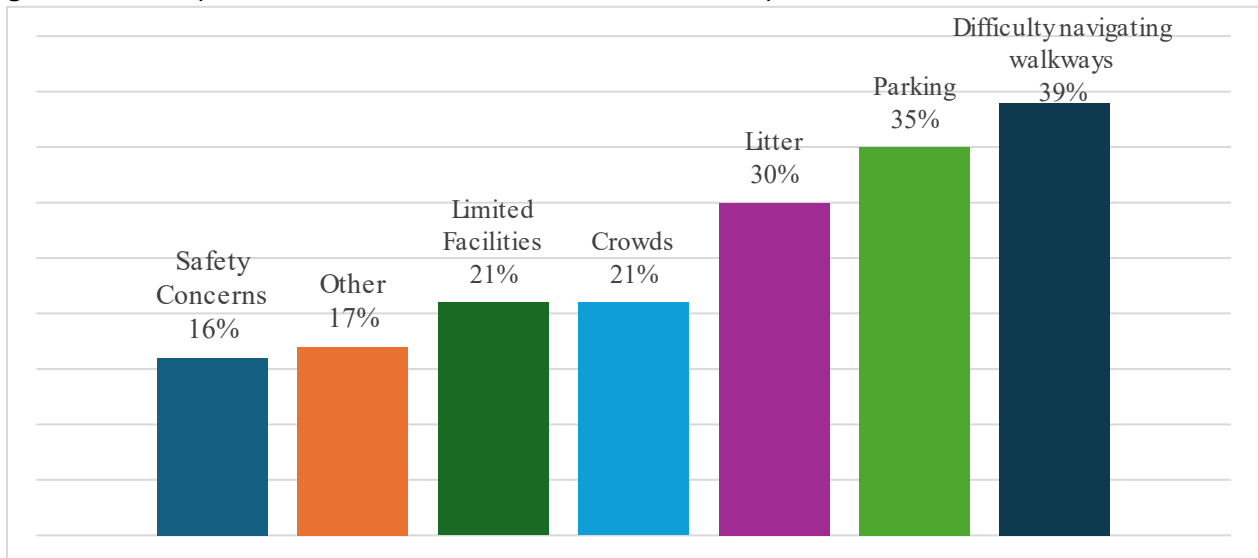
Question 8: Where do you find information on Seabrook Beach? Select all that apply. (Total Responses: 265)

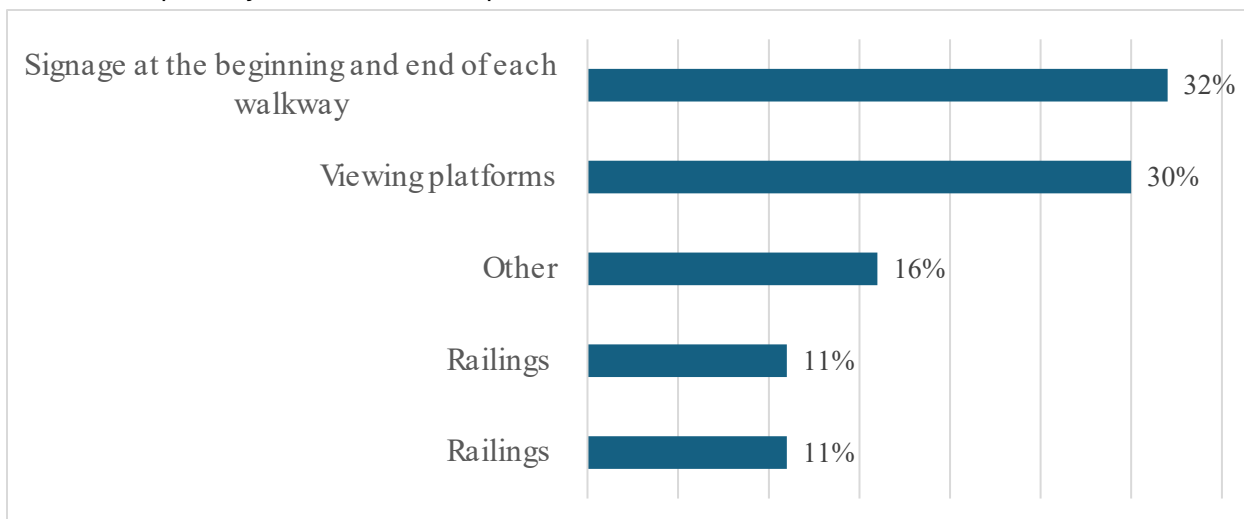
**Question 12: What improvements would you like to see for the municipal dune walkways?
Select all that apply. (Total Responses: 260)**

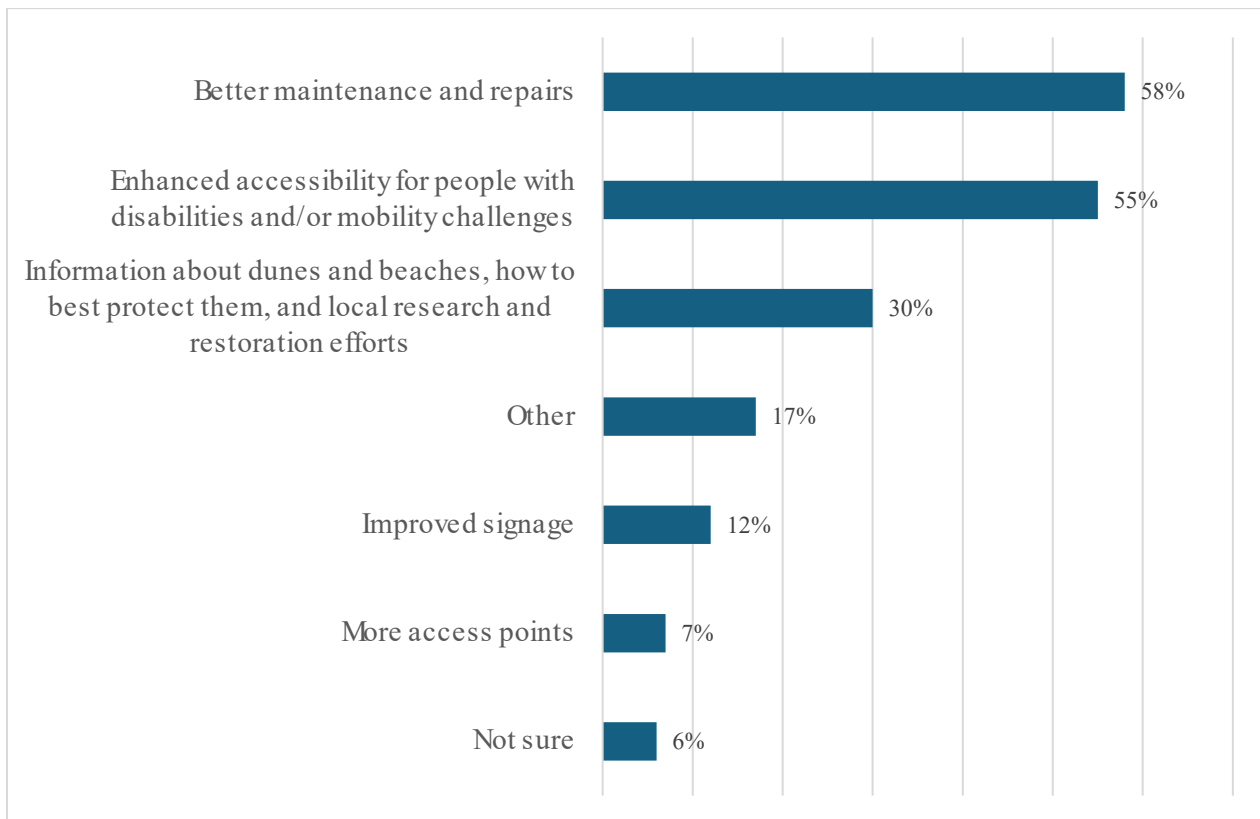
Question 13: Do you have any other questions or concerns about the municipal dune walkways?
